## Technical Memorandum

**RE:** **2018 STUMP LAKE EMERGENCY RESPONSE**  
**Stump Lake Site Visit and Downstream Assessment**  
**Our File 2755.006-300**

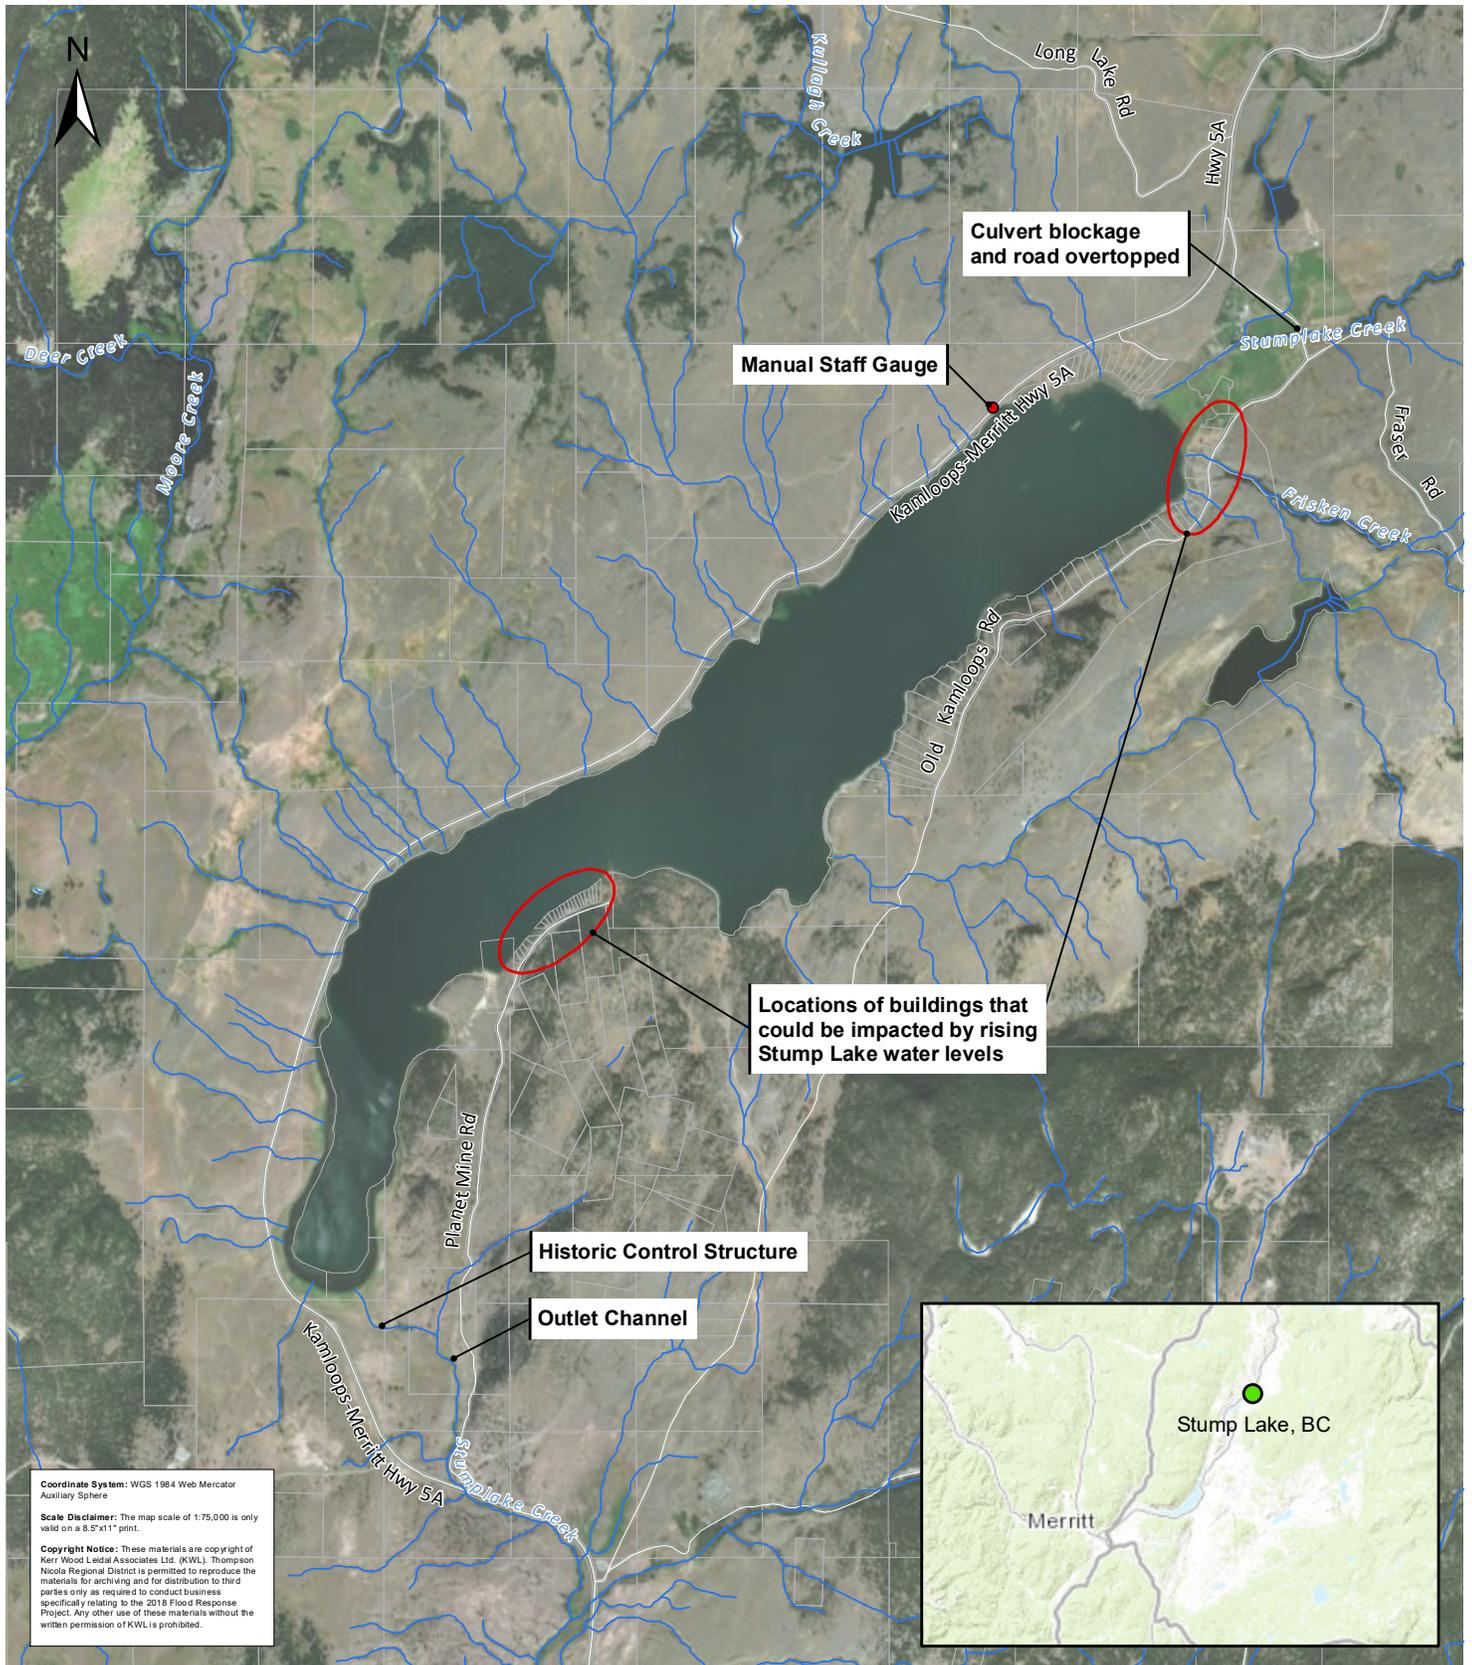
Figure 1

The site visit started at the north end of the lake. A culvert on Stumplake Creek, the main tributary flowing into Stump Lake (Figure 1), was blocked. This caused overtopping of the road and subsequent erosion to the road, cutting off road access and flooding a field at Stump Lake Ranch. The flow in the tributary was estimated to be 1 m<sup>3</sup>/s to 2 m<sup>3</sup>/s.

A manual staff gauge was installed at an access on the northwest corner of the lake, near the north side boat launch (Figure 1). KWL understands that the individuals who may read the staff gauge also reside at the north end of the lake. Immediately following installation, the staff gauge read 0.5 inches.

Next, the outlet of Stump Lake was assessed. At this location the remnants of an historical control structure were observed; the works included earthworks berms and a decant channel (Figure 1). However, it was apparent from the condition of the works that none of the elements had been functional for many years. Based on information Jephtha Ball collected in 2017, it is estimated the decant channel invert is about 1.5 m in elevation above the lake level (at the time of the April 28, 2018 site visit).

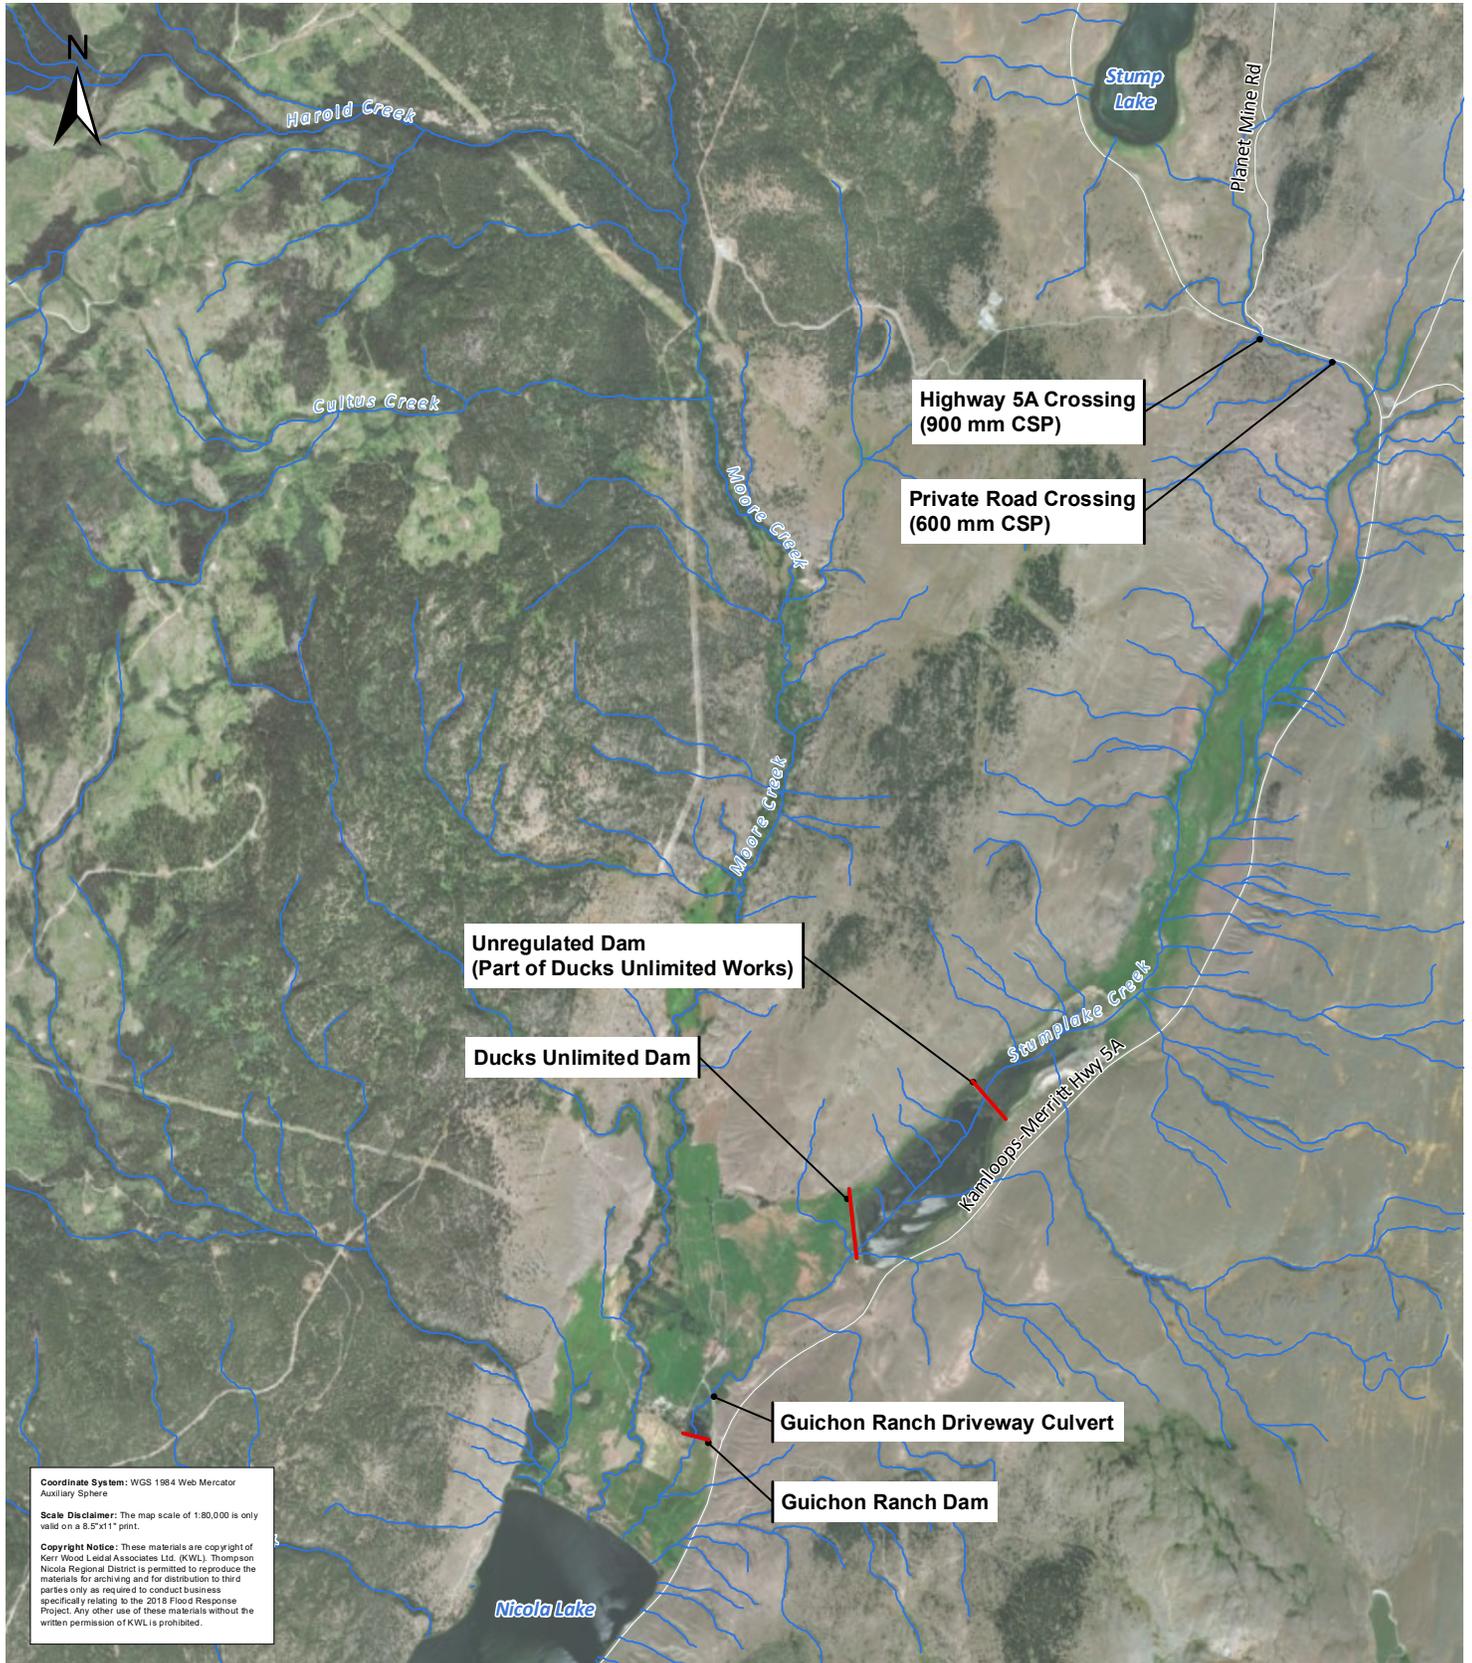
Figure 2

Finally, the site visit assessed the potential surface flow route that Stump Lake outflow would take if the lake were to rise above the decant channel invert (Figure 2). Ultimately, the outflow from Stump Lake would reach Nicola Lake. The following infrastructure was noted along the outflow route (from Stump Lake, moving in downstream order):

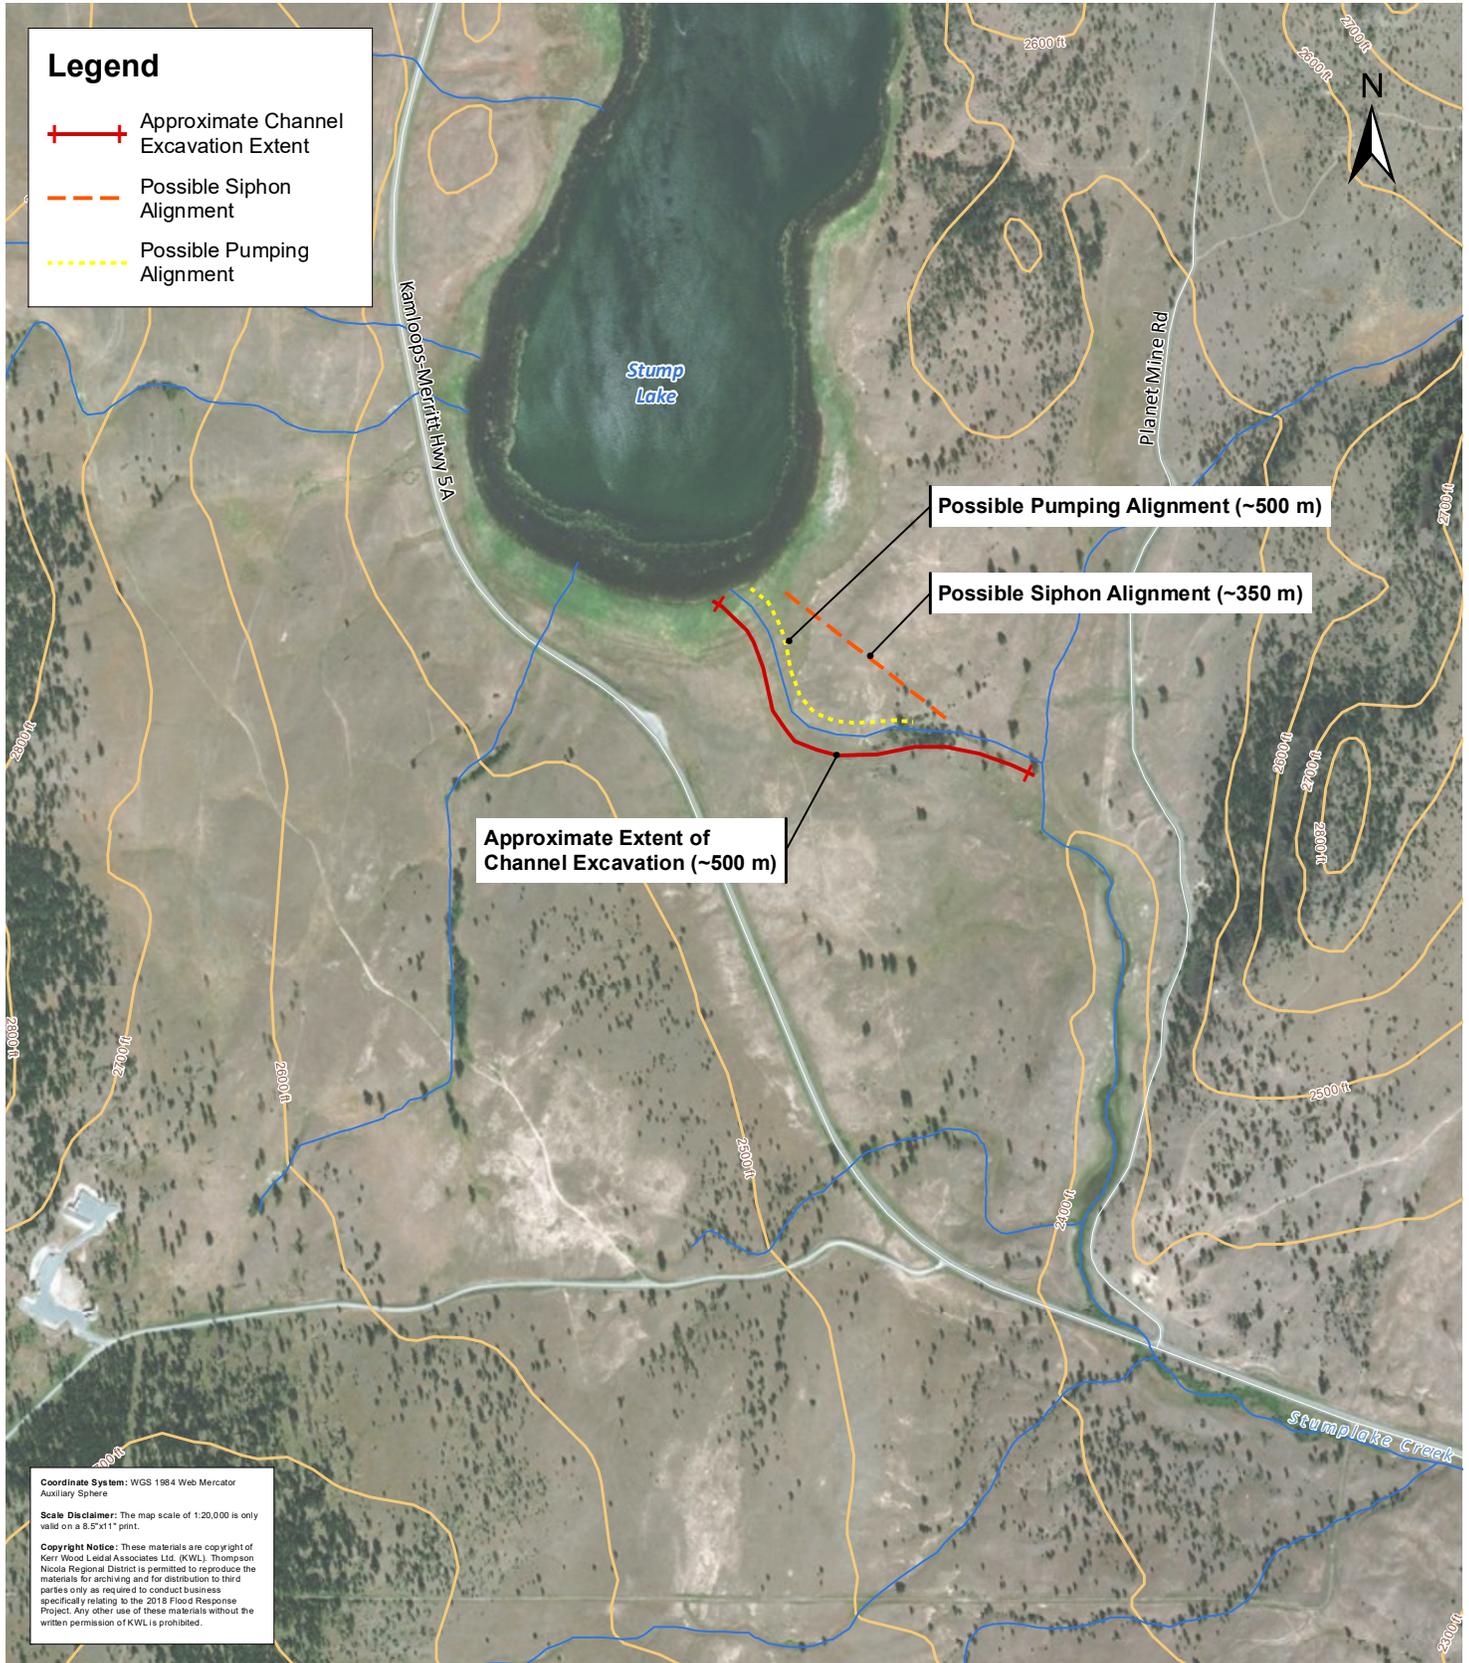
Figure 3

Downstream of the noted infrastructure, the outflow would flow through open agricultural fields approximately 900 m before entering Nicola Lake (Figure 3).

Possible options are described below and shown conceptually on Figure 3. The timeframe for the options is based from the time of option initiation (i.e. once approvals are in place).
