Preliminary Hydrogeological Assessment for Vavenby Groundwater Issues, Vavenby, B.C.

February 2020
Project: 19-033-01

Re: Preliminary hydrogeological assessment – to address ongoing management of groundwater flow, Vavenby B.C.

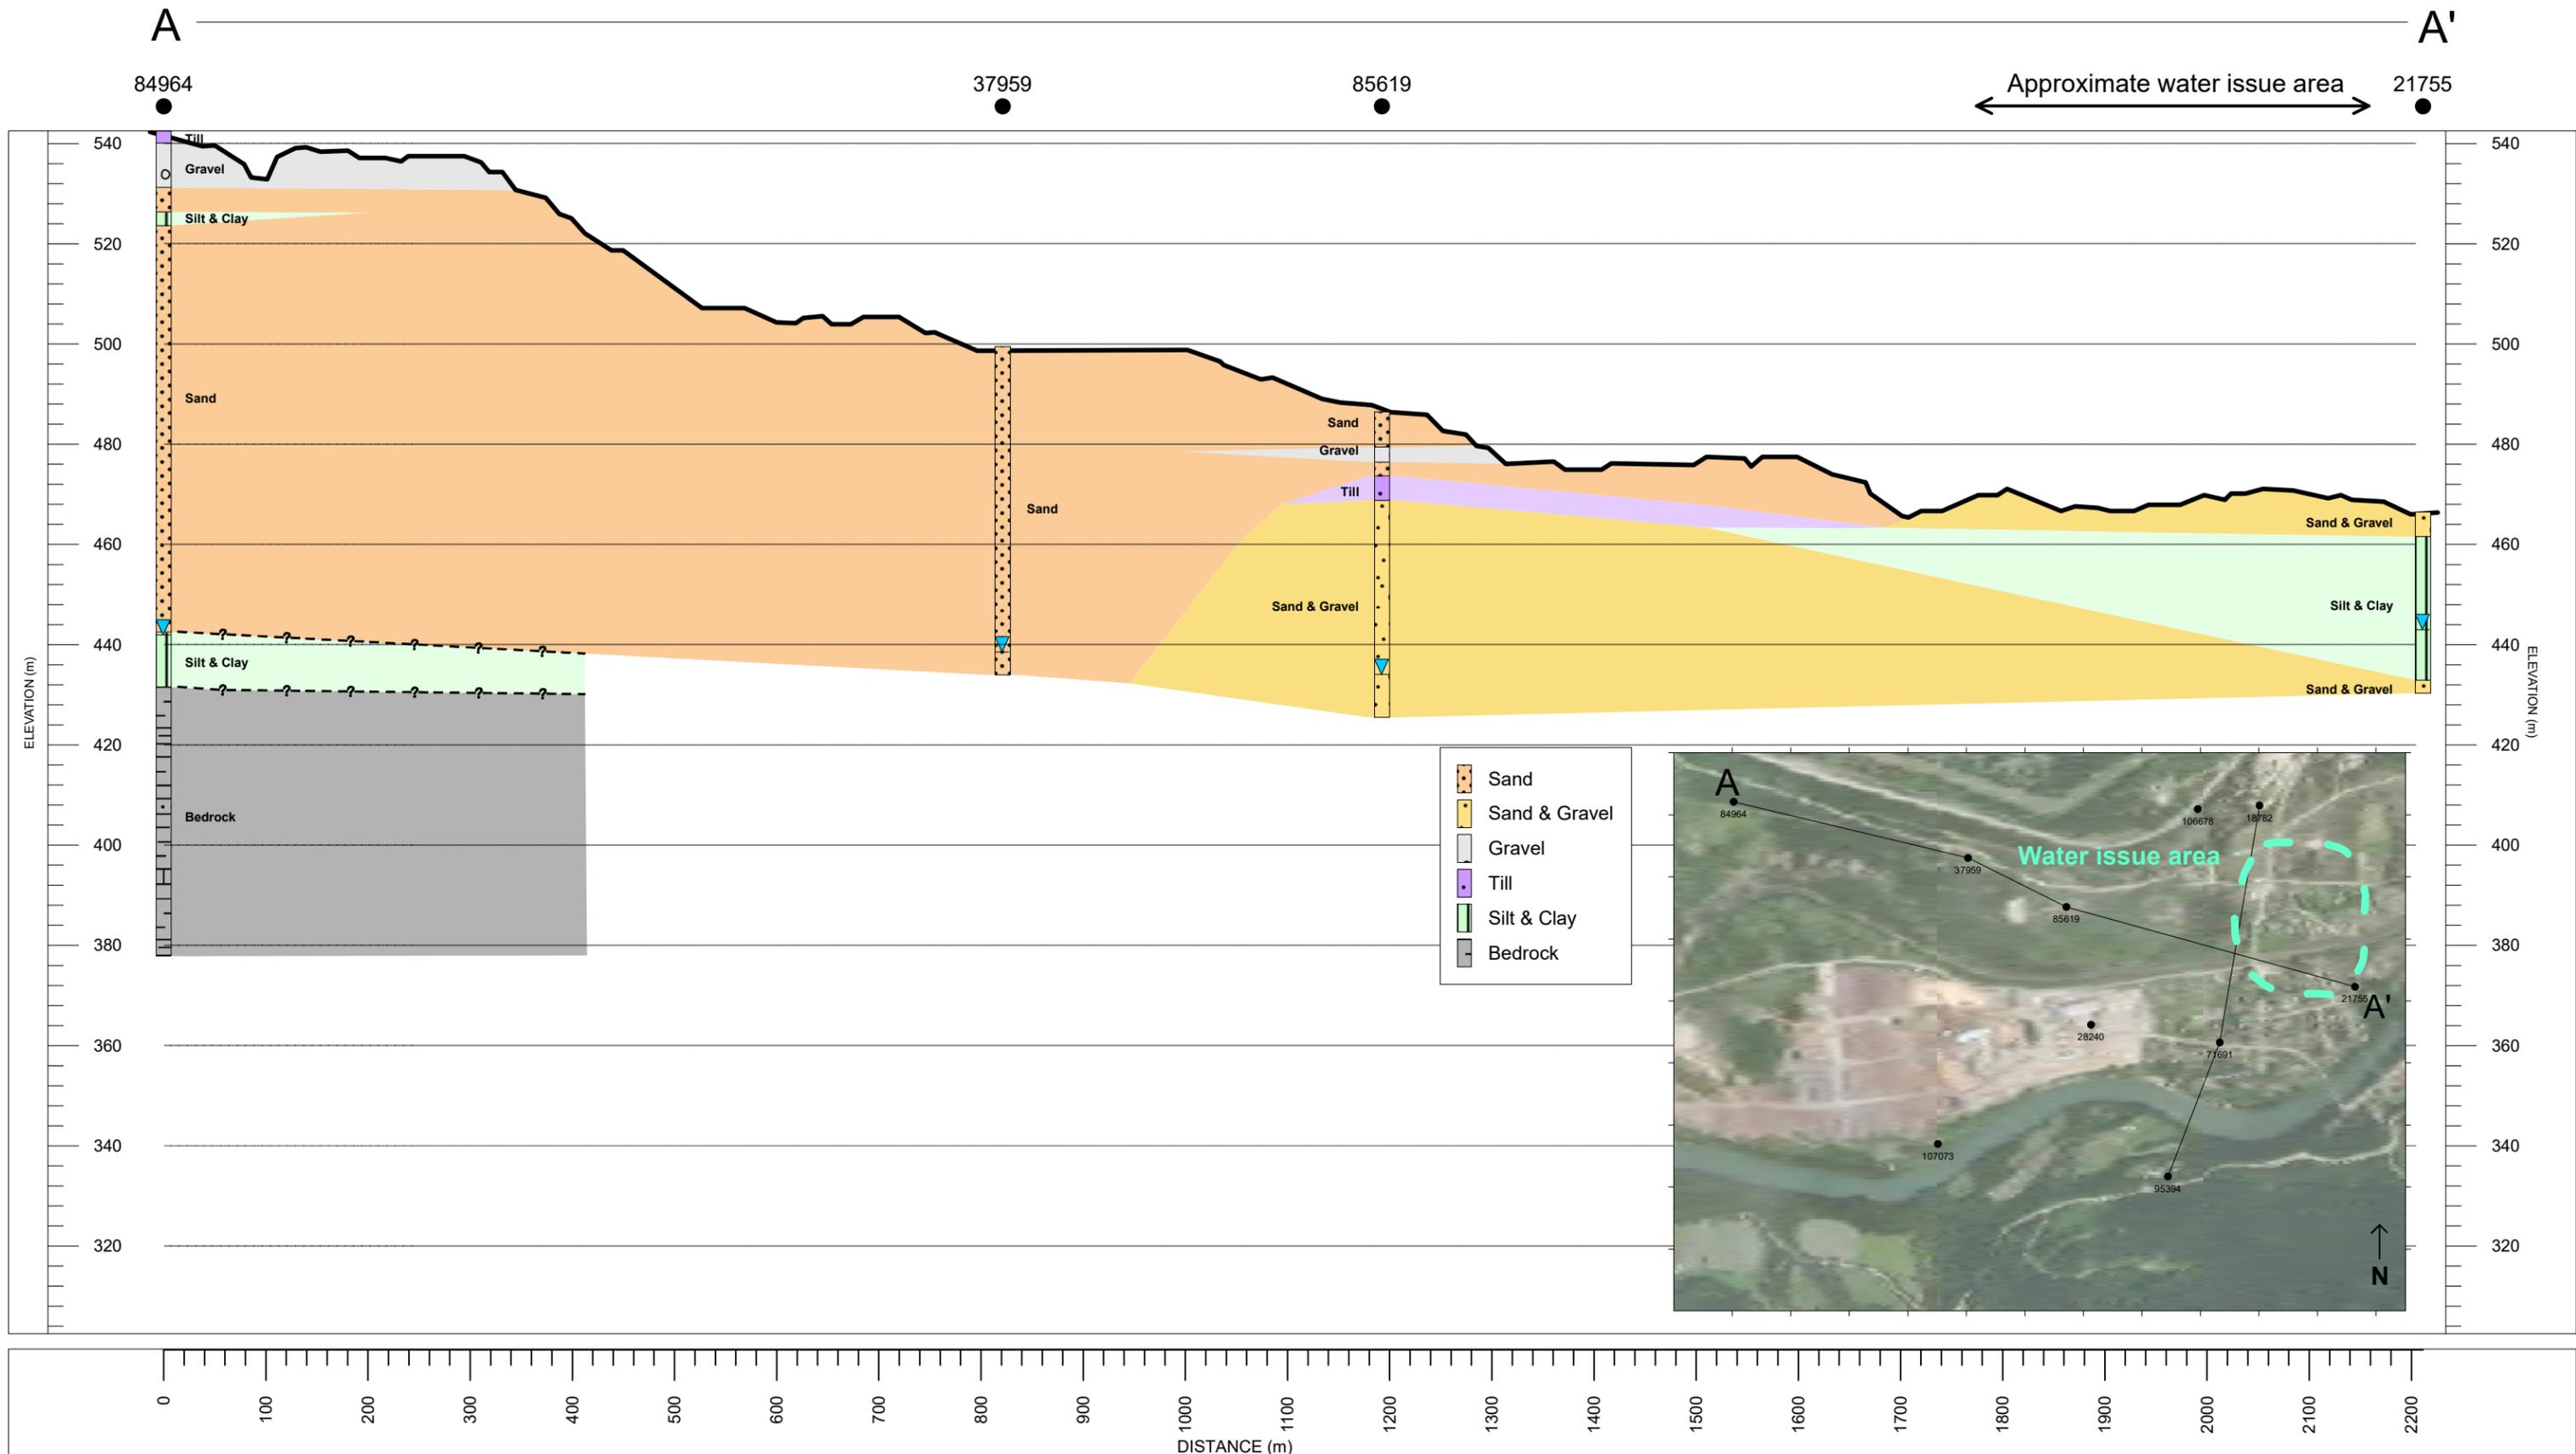
| | Preliminary Groundwater Assessment for Vavenby | | Figure 2. Cross-section A-A' | | Notes: Map Projection: NAD83 UTM Zone 11 Vertical Exaggeration: 4.9x |

In both cross sections A-A' and B-B' an approximately 10 m thick silt and clay layer is present beneath the area identified as having groundwater issues (Figures 2 and 3). Above the 10 m thick silt and clay layer is sand and gravel present in the upper terrace formations. The presence of this silt and clay is significant and is likely the underlying reason for the groundwater issues experienced by some of the community in the area denoted on Figure 1.

groundwater flow, driven by local precipitation and snowmelt within the identified unconfined upper sand and gravel unit that sits atop till, which transition into silt and clay at the 'water issue area' of Vavenby (Figures 2 and 3). Locally, on the northwest side of the River, water moves from the upper plateau towards the River from north to south-southeast. As that water attempts to infiltrate on its flow paths towards the river it is seeing downward flow restriction due to the low permeability silt and clay wedge encountered in the vicinity of the water issue area.

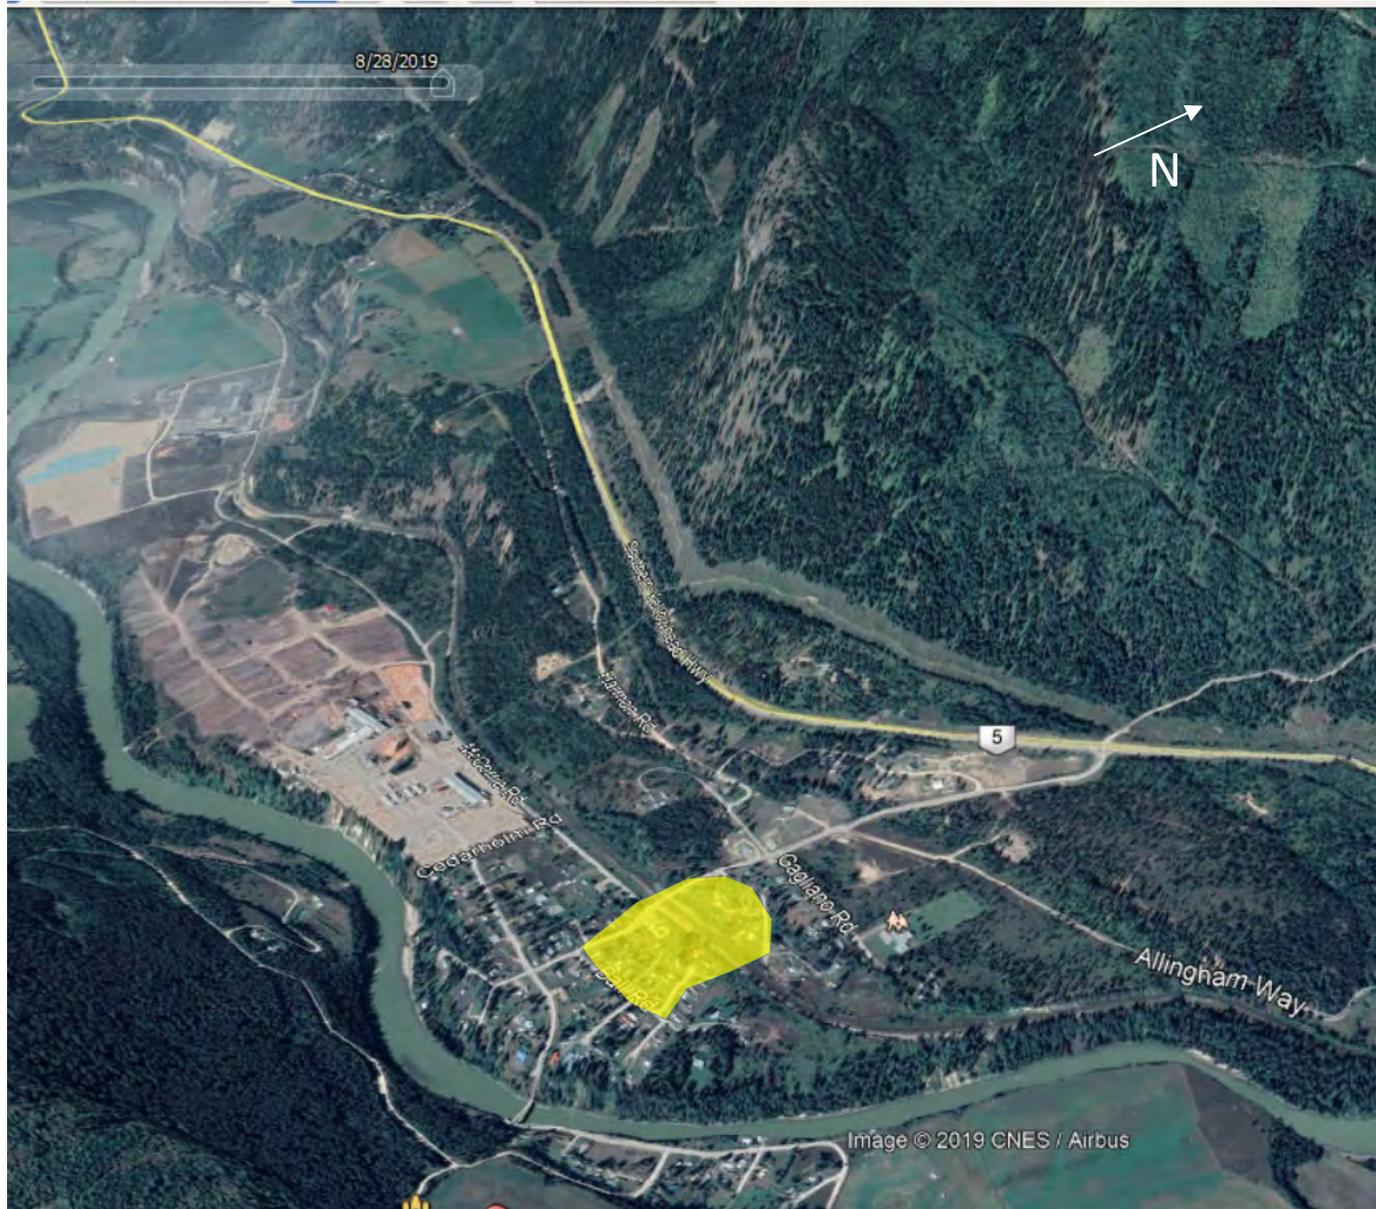
From interviews with local residents, numerous property owners have had high groundwater issues primarily during spring freshet and the summer melt in the area(s) shown on Figures 1, 4 and 5. We understand there are numerous properties that have been affected by groundwater flow issues between the area encompassing Galiano Road, Hudsbedt Road, Wood Road and McCorvie Road/Vavenby Bridge Road and along Ball Road (Figures 4 and 5 and Appendix A Vavenby Water System Map). However, we interviewed only three property owners on the northwest side of the River.

Area identified as having groundwater / surface water drainage issues
