Preliminary Hydrogeological Assessment for Vavenby Groundwater Issues, Vavenby, B.C.

February 2020
Project: 19-033-01

Re: Preliminary hydrogeological assessment – to address ongoing management of groundwater flow, Vavenby B.C.

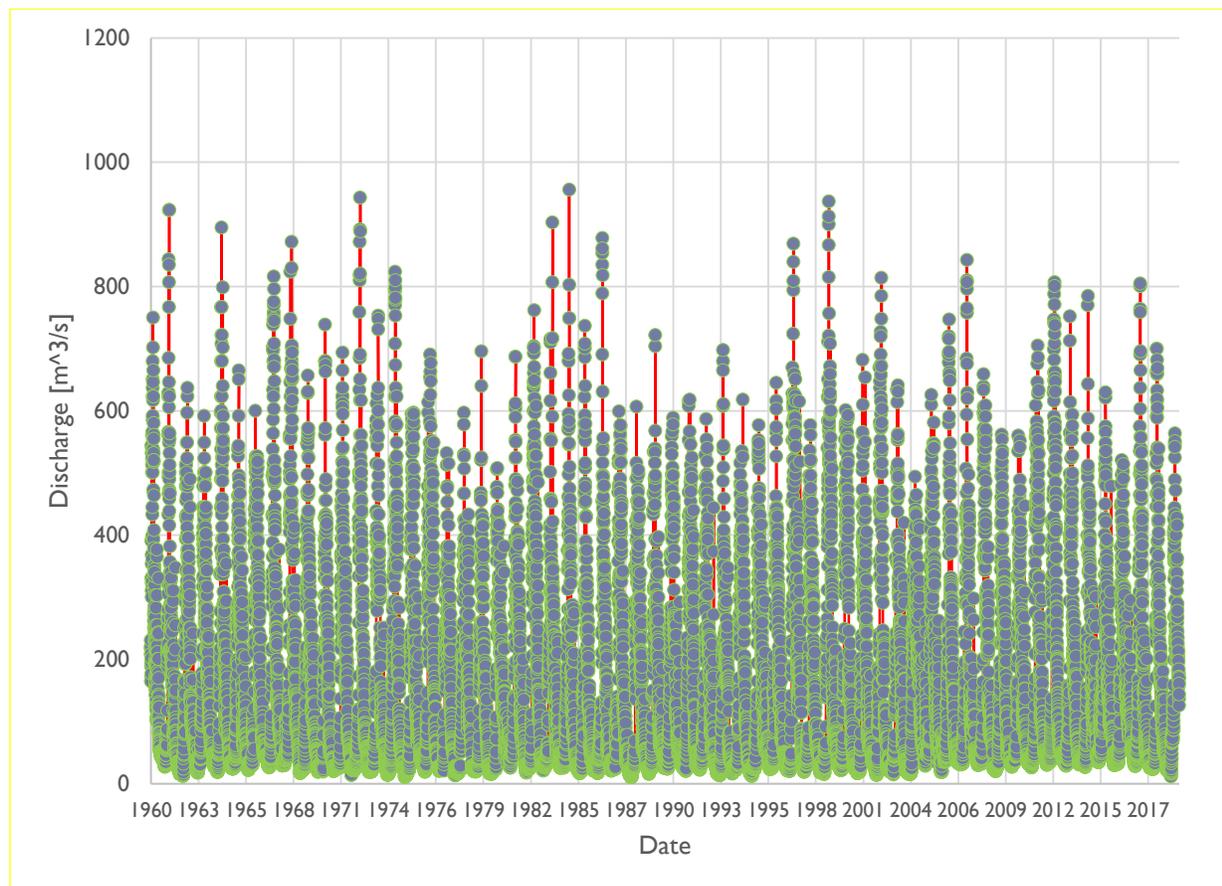
Plot I: Mean Daily Discharge – North Thompson River at Birch Island 1960 - 2019

Plot 1 below shows discharge in the North Thompson River at Birch Island (just downgradient of Vavenby) from between 1960 and 2019 (Environment Canada 2019). Typically the annual hydrograph for the North Thompson River at Birch Island peaks in June, with the lowest discharges occurring in about January. Peak discharge in the North Thompson River can range between about 500 m³/sec and over 900 m³/sec depending on the seasonal snow melt occurring in the upper reaches of the watershed.

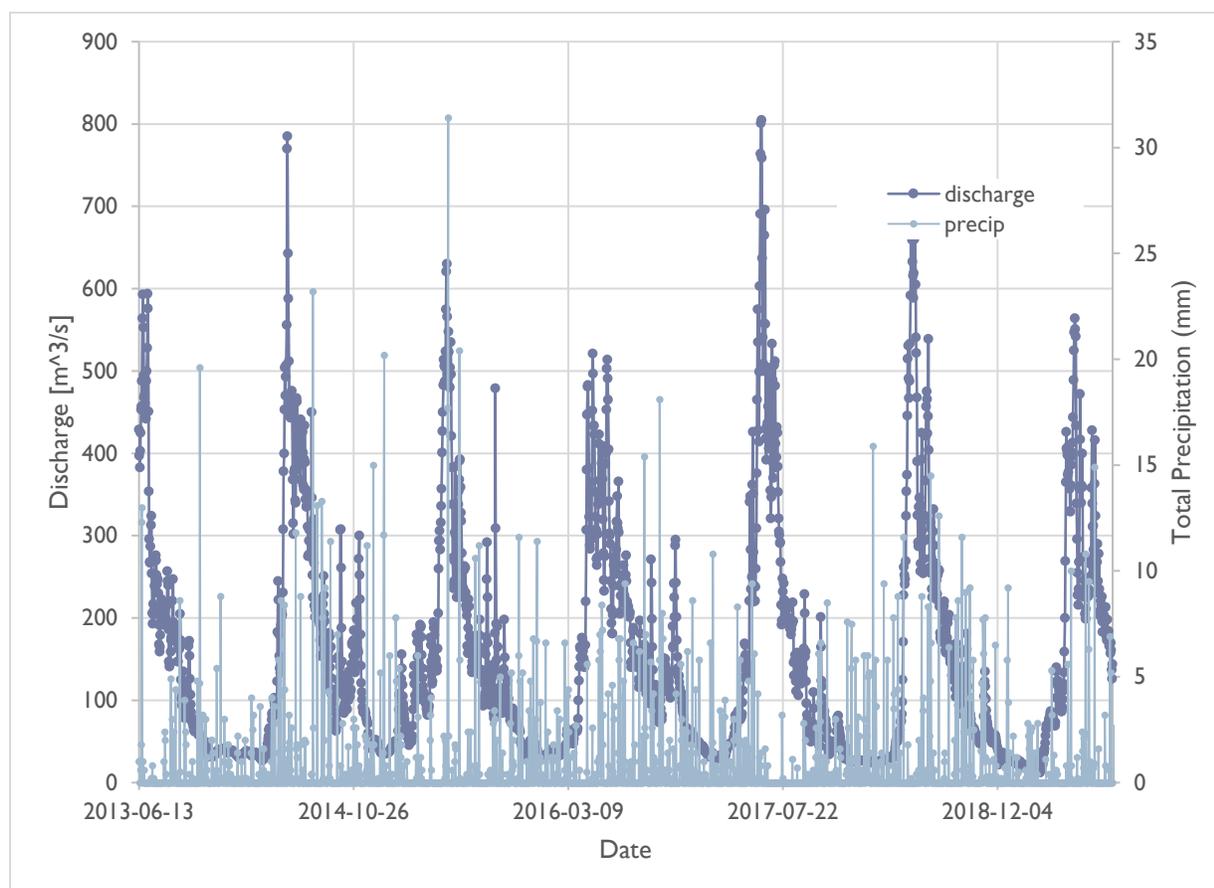
Plot 2: Mean Daily Discharge and Total Precipitation – North Thompson River at Birch Island 2013 - 2019

Plot 2 displays the mean daily discharge for the North Thompson River at Birch Island and daily total precipitation from the climate station at Kamloops for the years 2013 through 2019 (September). Although there can be a direct relationship between precipitation and increase in discharge in the River that relationship is not always observed. Likely, peak discharge the North Thompson River is driven by snow melt in the upper watershed as opposed to direct infiltration at the lower elevations.

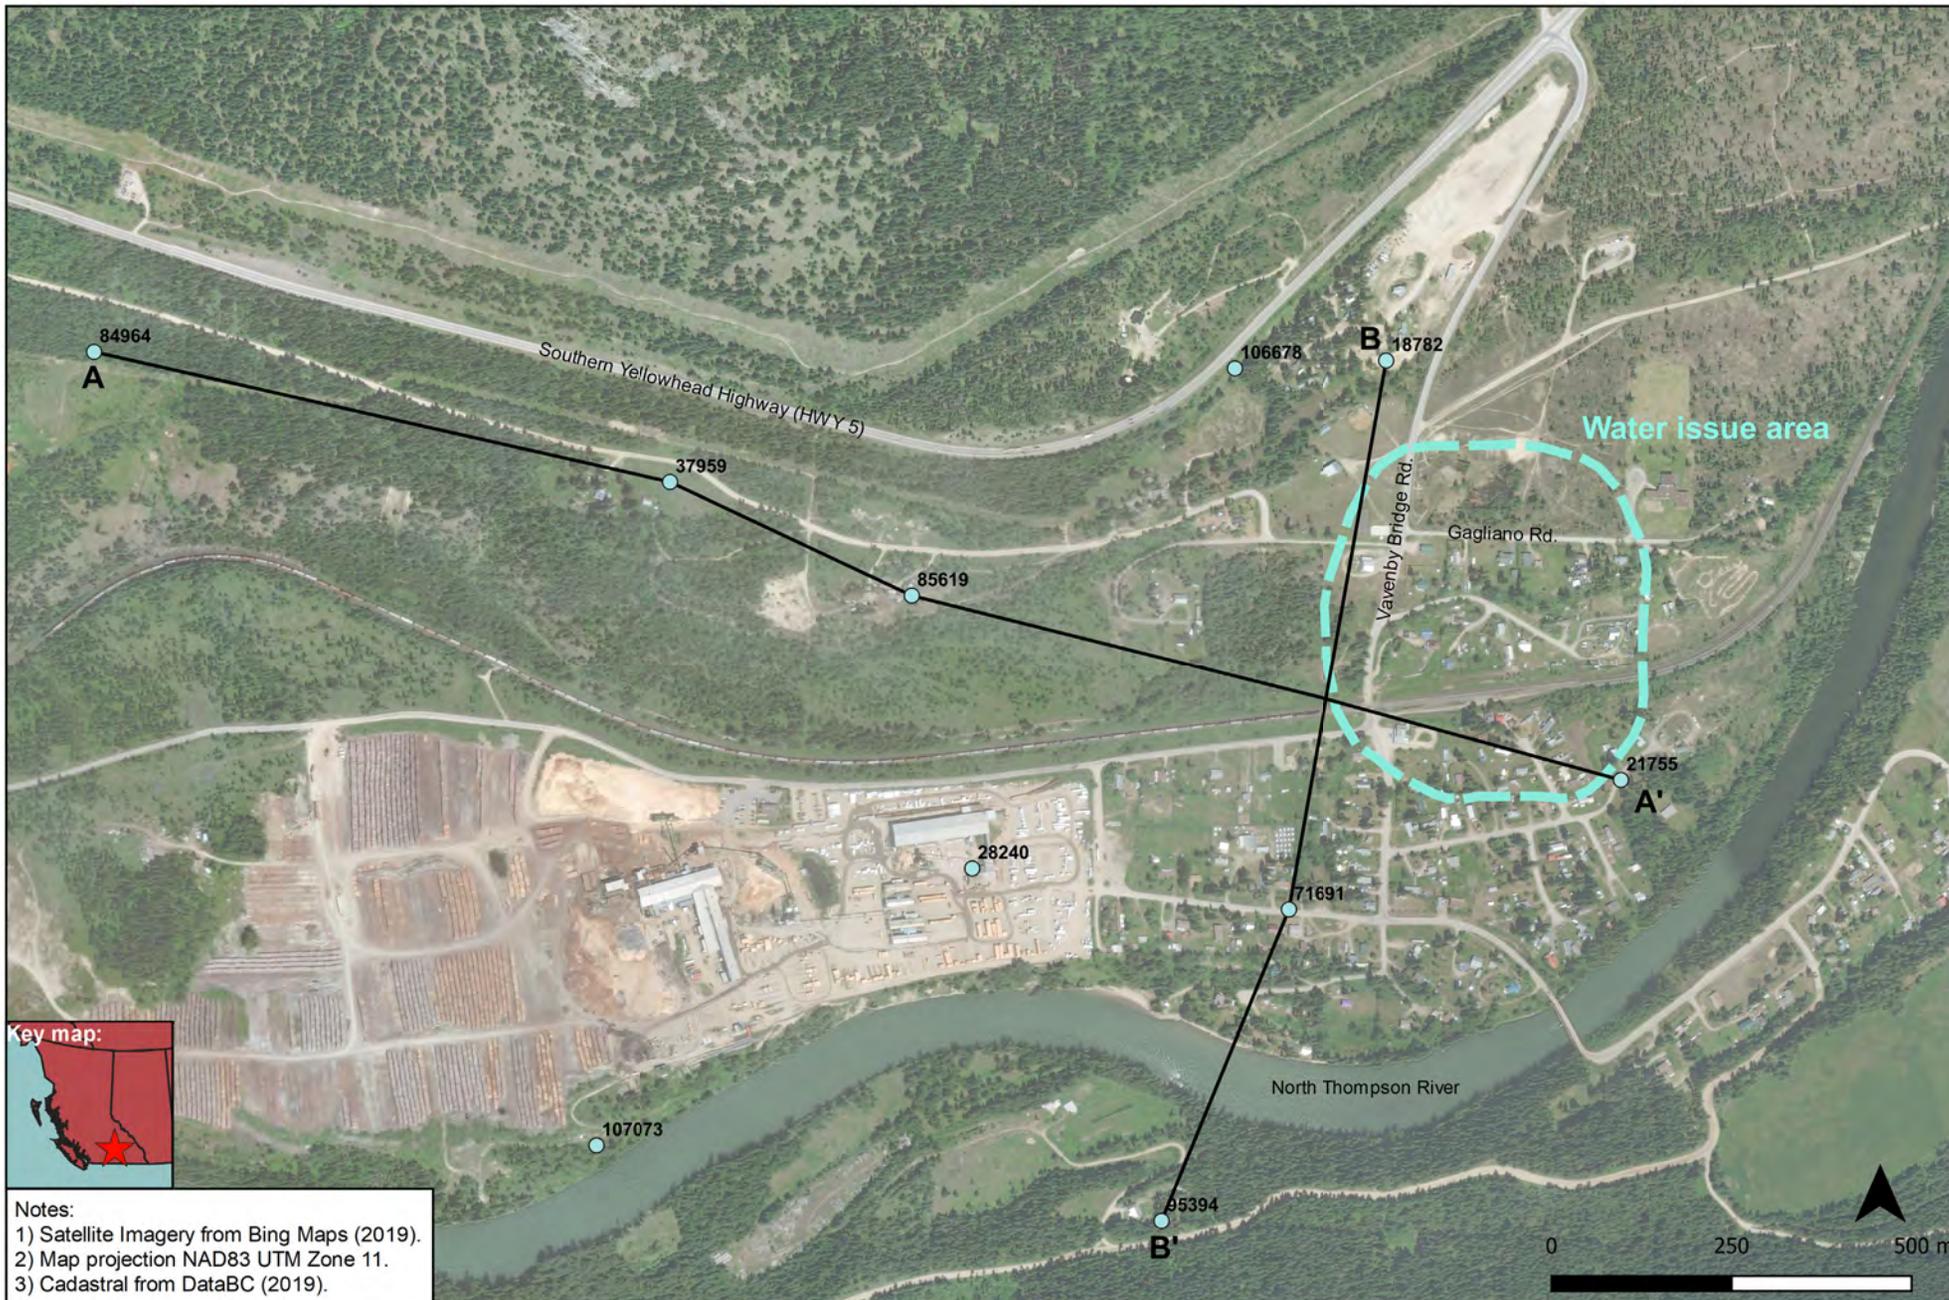
| Preliminary Groundwater Assessment for Vavenby | TITLE Figure 1: Location Plan | | 0 250 500 m |

In both cross sections A-A' and B-B' an approximately 10 m thick silt and clay layer is present beneath the area identified as having groundwater issues (Figures 2 and 3). Above the 10 m thick silt and clay layer is sand and gravel present in the upper terrace formations. The presence of this silt and clay is significant and is likely the underlying reason for the groundwater issues experienced by some of the community in the area denoted on Figure 1.

Area identified as having groundwater / surface water drainage issues
